UNITED STATES ENVIRONMENTAL PROTECTION AGENCY  
REGION II  
EDISON, NEW JERSEY 08837

**RESPONSE AND PREVENTION BRANCH**  
**MINI POLLUTION REPORT**

ERNS NO.: N/A LOCATION: Union Twp., Union Co., New Jersey  
RELEASE DATE: Ongoing NOTIFICATION: 2/16/01 RESPONSE: 2/16/01  
MATERIAL RELEASED: Sodium hydrosulfite, sodium hydroxide  
RESPONSIBLE PARTY: Schaeffer Salts  
OFFICIALS ON SCENE:  
FEDERAL: D. Perera, OSC  
C. Jimenez, OSC  
STATE: H. Camargo, NJDEP-BER  
MUNICIPALITY:

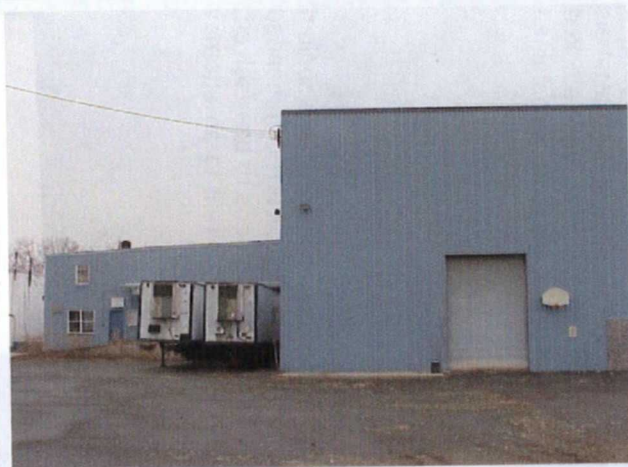
Front view of the main warehouse

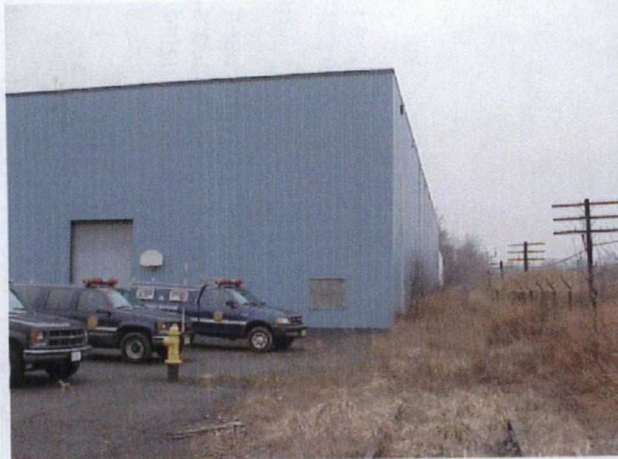
Front and side view of the main warehouse

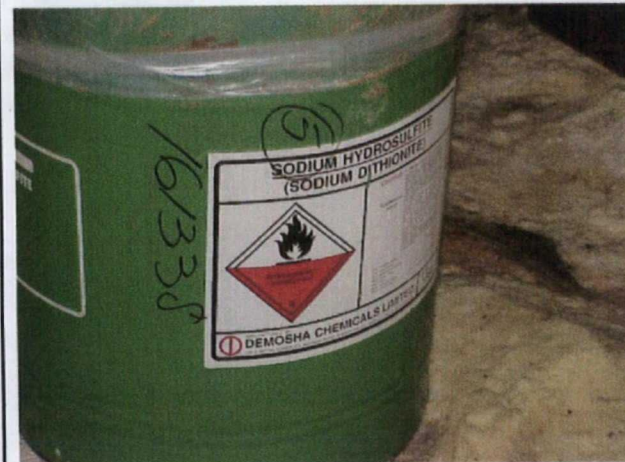
An example of the Sodium hydrosulfite containers found throughout the main warehouse

NJDEP-BER is requesting that EPA conduct a time critical removal action at this site. Based on the condition of the sodium hydroxide containers and what is believed to be spilt sodium hydrosulfite in the main ware house building, it is recommended that verbal authorization be sought to initiate site stabilization and security. The issue of ownership needs to be resolved. According to local officials, the facility is bankrupt, however, the tenant is continuing to submit the rent to an attorney representing the owner.

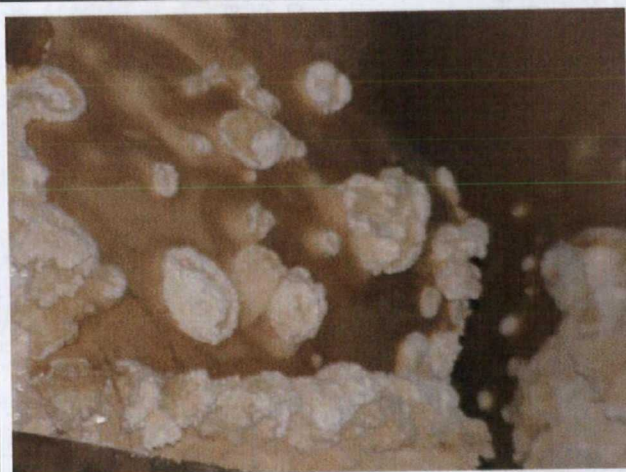
EPA was notified of the site on February 16, 2001. On this same date OSCs met with officials from NJDEP-BER and toured the site. The primary storage building, approximately 75ftX200ft, contained approximately 50 sodium hydrosulfite and 75 fiber drums of sodium hydroxide. The containers were labeled corrosive and in the case of the hydrosulfite, additional labels identified it as a flammable and a water reactive was noted. The fiber drums containing the hydroxide were triple stacked and in extremely poor condition. Other pails with corrosive labels were identified, though most of the visible pails contained two or less inches of a liquid product. The main warehouse building is not secure and is accessed by the tenant.

A close up of the deteriorating sodium hydroxide fiber drums

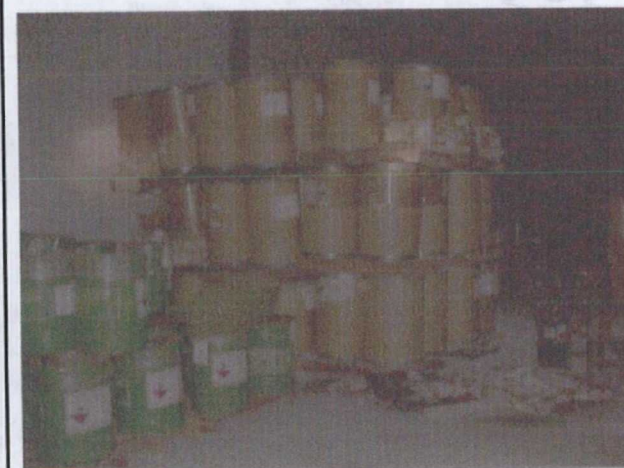
One of the staging area for the sodium hydroxide and hydrosulfite. One can note the poor condition of the fiber drums and spilt material on the floor.
